Chapter 13

Mitigating Coastal Erosion in Fort Dauphin, Madagascar

Abstract The city of Fort Dauphin is one of the most attractive tourist spots in Madagascar. In recent years, it has become one of the development centers of the island. However, the city is facing coastal erosion related to human activity as well as natural factors. Mitigation of coastal erosion at the catchment and regional scale is extremely important for the sustainable economic and social development of this region. Spatial analysis using satellite imagery over a long period has been considered as an important tool for determining the extent of the most affected areas and for analyzing how the erosion has developed in the past and at present. Measurement and field work need to be integrated to develop appropriate strategies to mitigate the problems. Satellite imagery analysis in combination with field work and measurement consists of generating long-term information required to determine threats and pressures in time and space. It takes into consideration assessment of land use, the geology of the area, urban planning, local and regional climate, and coastal management. Madagascar faces multiple challenges in

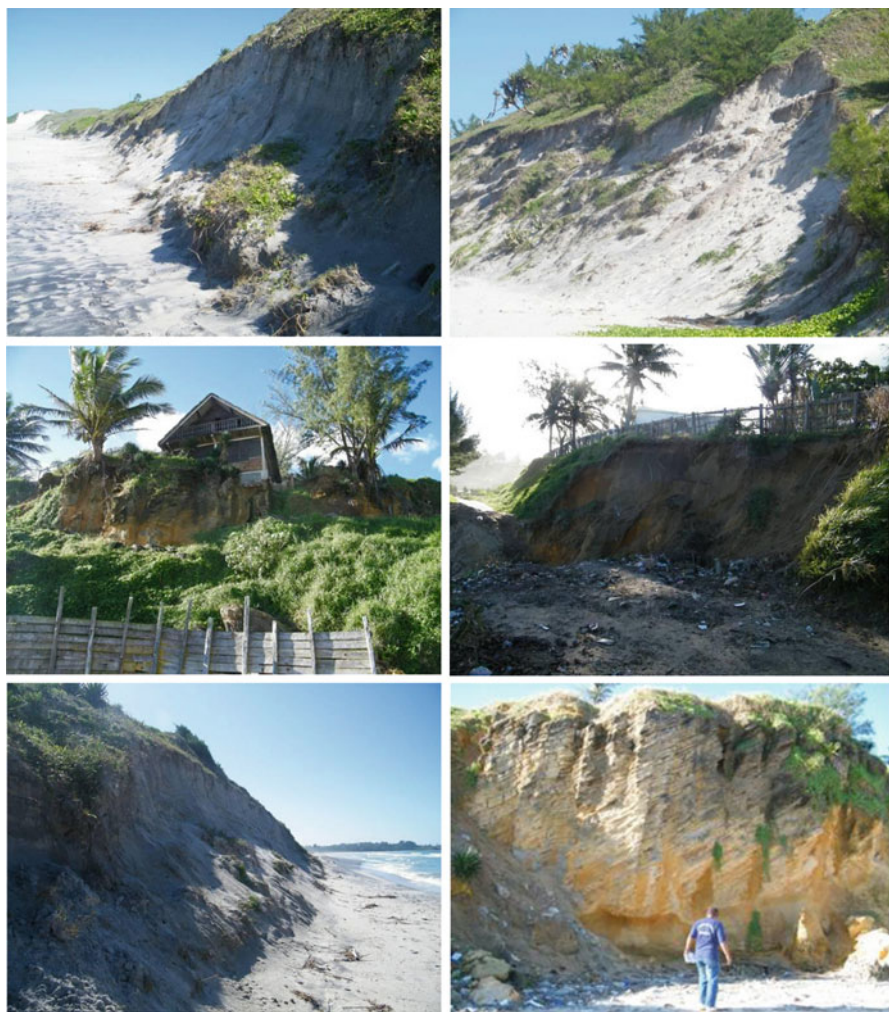
The impacts of coastal erosion most frequently encountered in Fort Dauphin can be grouped into three categories: coastal flooding as a result of dune erosion, undermining of sea defenses associated with foreshore and subaerial erosion, and retreating cliffs, beaches, and dunes causing loss of land (Fig. 13.4).

Fig. 13.4 Impacts of coastal erosion in Fort Dauphin

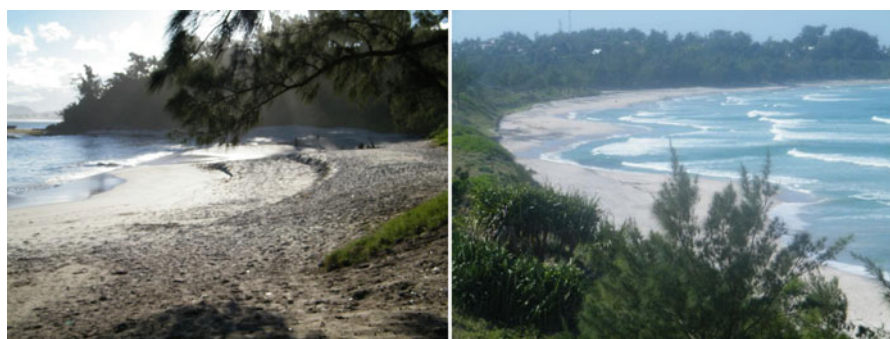
Fig. 13.9 Image showing the actual state of Libanona in Galions Bay, 2012

The manifestation and activity of these two parameters on beach and dunes could be explained by combinations of various natural forces such as the wave direction approach, as well as the dredging (digging) phenomenon in the coastal area. Before explaining the coastal erosion process in Fort Dauphin, it is interesting to remember that the surf zone is the area where waves break. It is a turbulent zone, as waves smash and dissipate their energy in this area while producing intense local currents that eventually reach the coastal shores (Hyndman 2006). During this turbulent time, water removes sediment in its path and then local currents carry it to the sea when leaving the coast. The same process occurs in the wave zone; in this zone, the depth of breaking varies depending on wave size (Hyndman 2006). This phenomenon is observed on all the beaches in Fort Dauphin, and beach and dune dredging appears in the same manner as shown in Fig. 13.9.

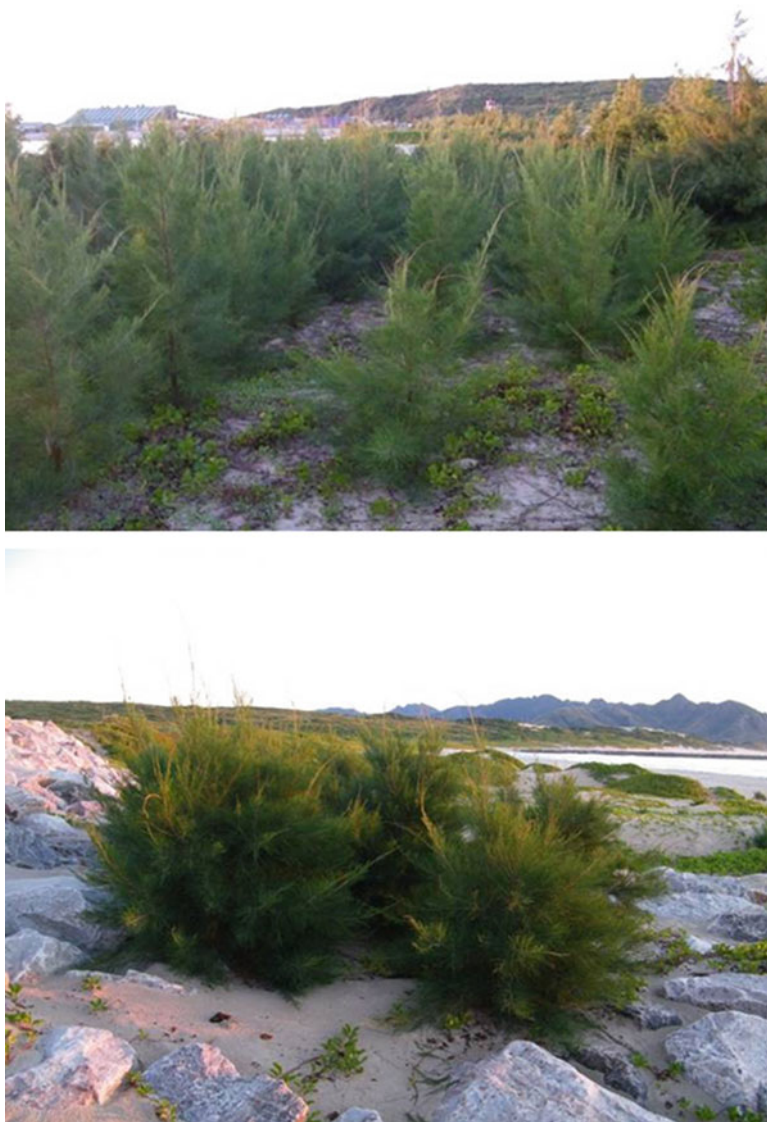
Fig. 13.13 Casuarinas trees planted near the Ehoala port

Once the dunes are stable, planted trees can withstand the actions of the wind over time. Use of *Vetiver* has already shown great success in watershed protection in Madagascar. This species is capable of sinking its roots up to three meters deep and grows almost everywhere. The same is true for *casuarinas*, which have already been planted in Fort Dauphin along the road leading to the Ehoala port as a kind of windbreak (Fig. 13.13). To date this species has grown well and met expectations.
